RIDGEWOOD BOARD OF EDUCATION

**REMEDIAL ACTION WORKPLAN**  
**ORCHARD SCHOOL PORTION OF THE**  
**RIDGEWOOD ASH LANDFILL**  
**PI ID #G000008572**

FEBRUARY 07, 2020

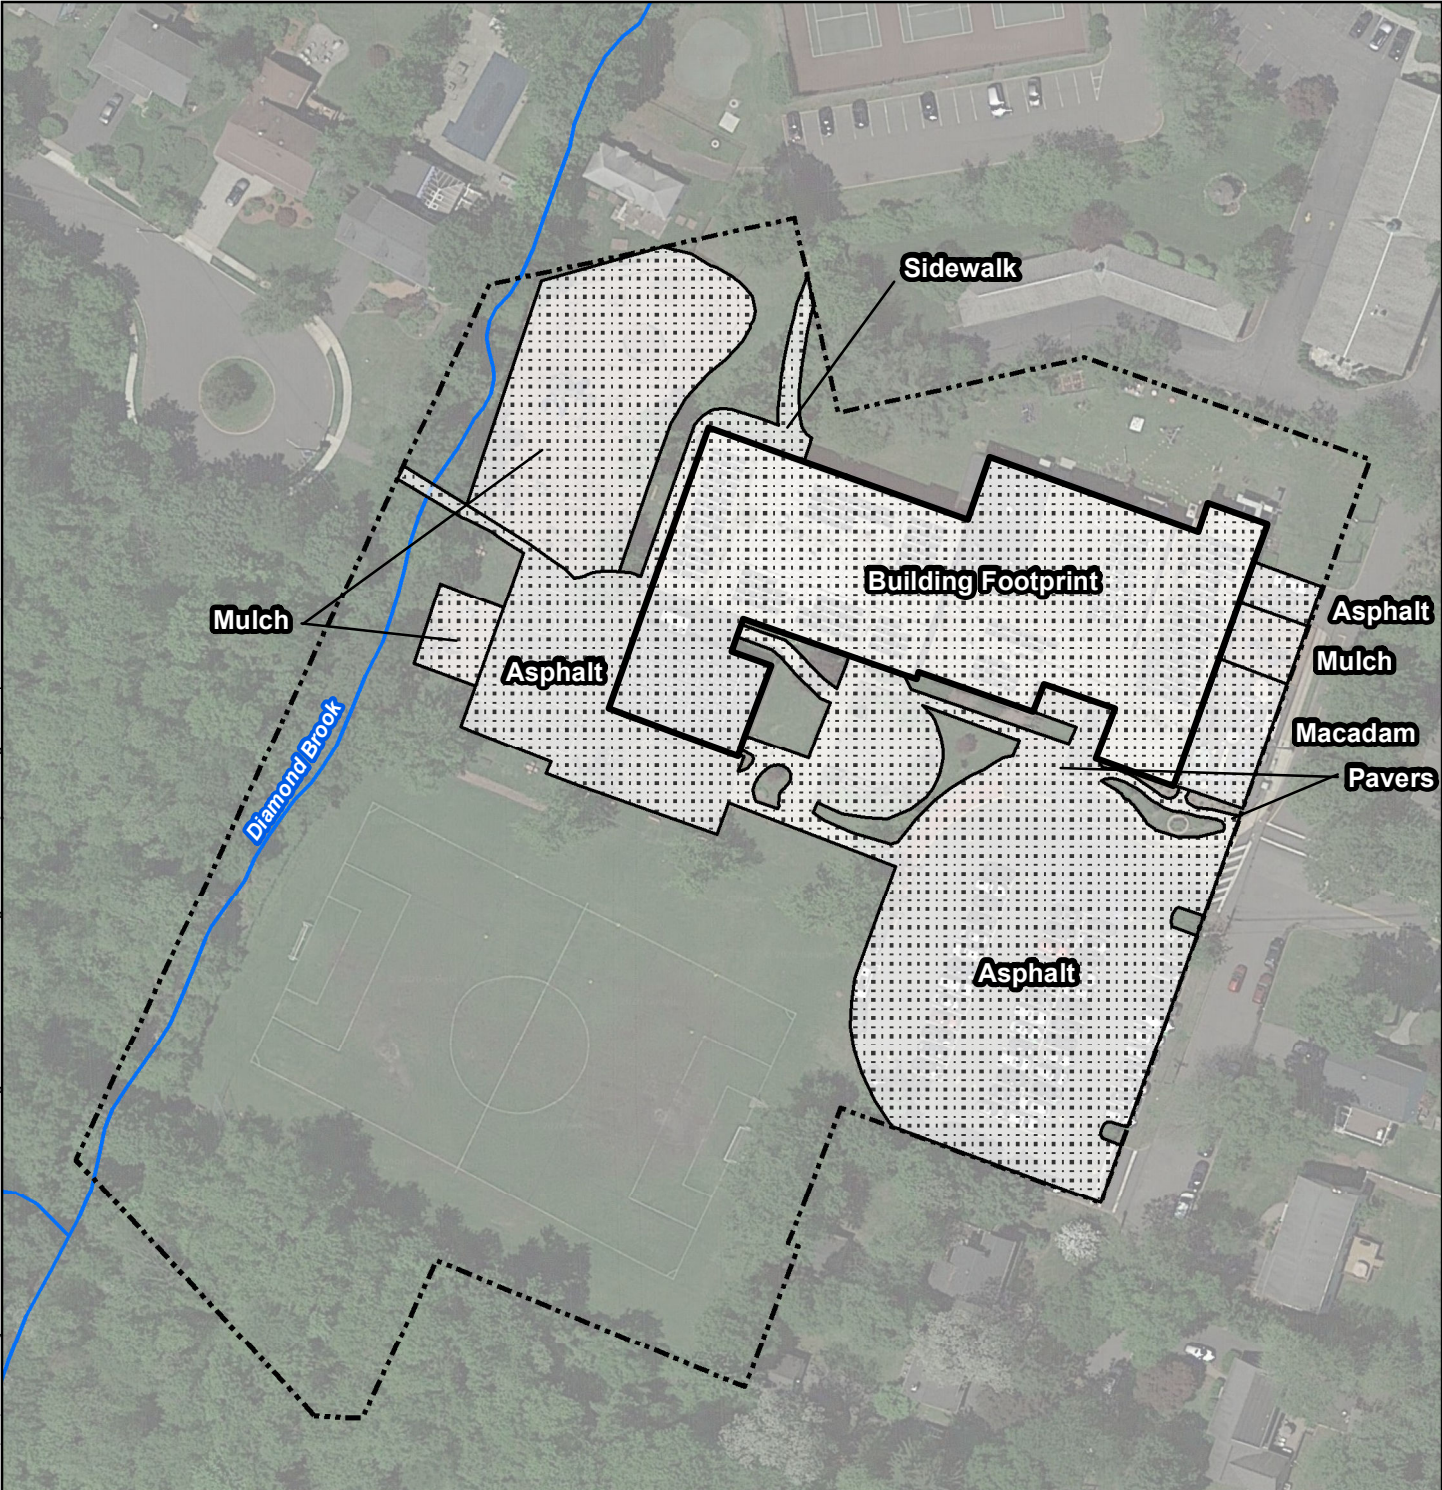
Office: Upper Saddle River, NJ, C:\Users\styczka\OneDrive - WSP\_03651\Ridgewood\Orchard School\GIS\RAW - F06 - Existing Soil Cap Areas.mxd; Printed 2/10/2020 11:31:58 AM

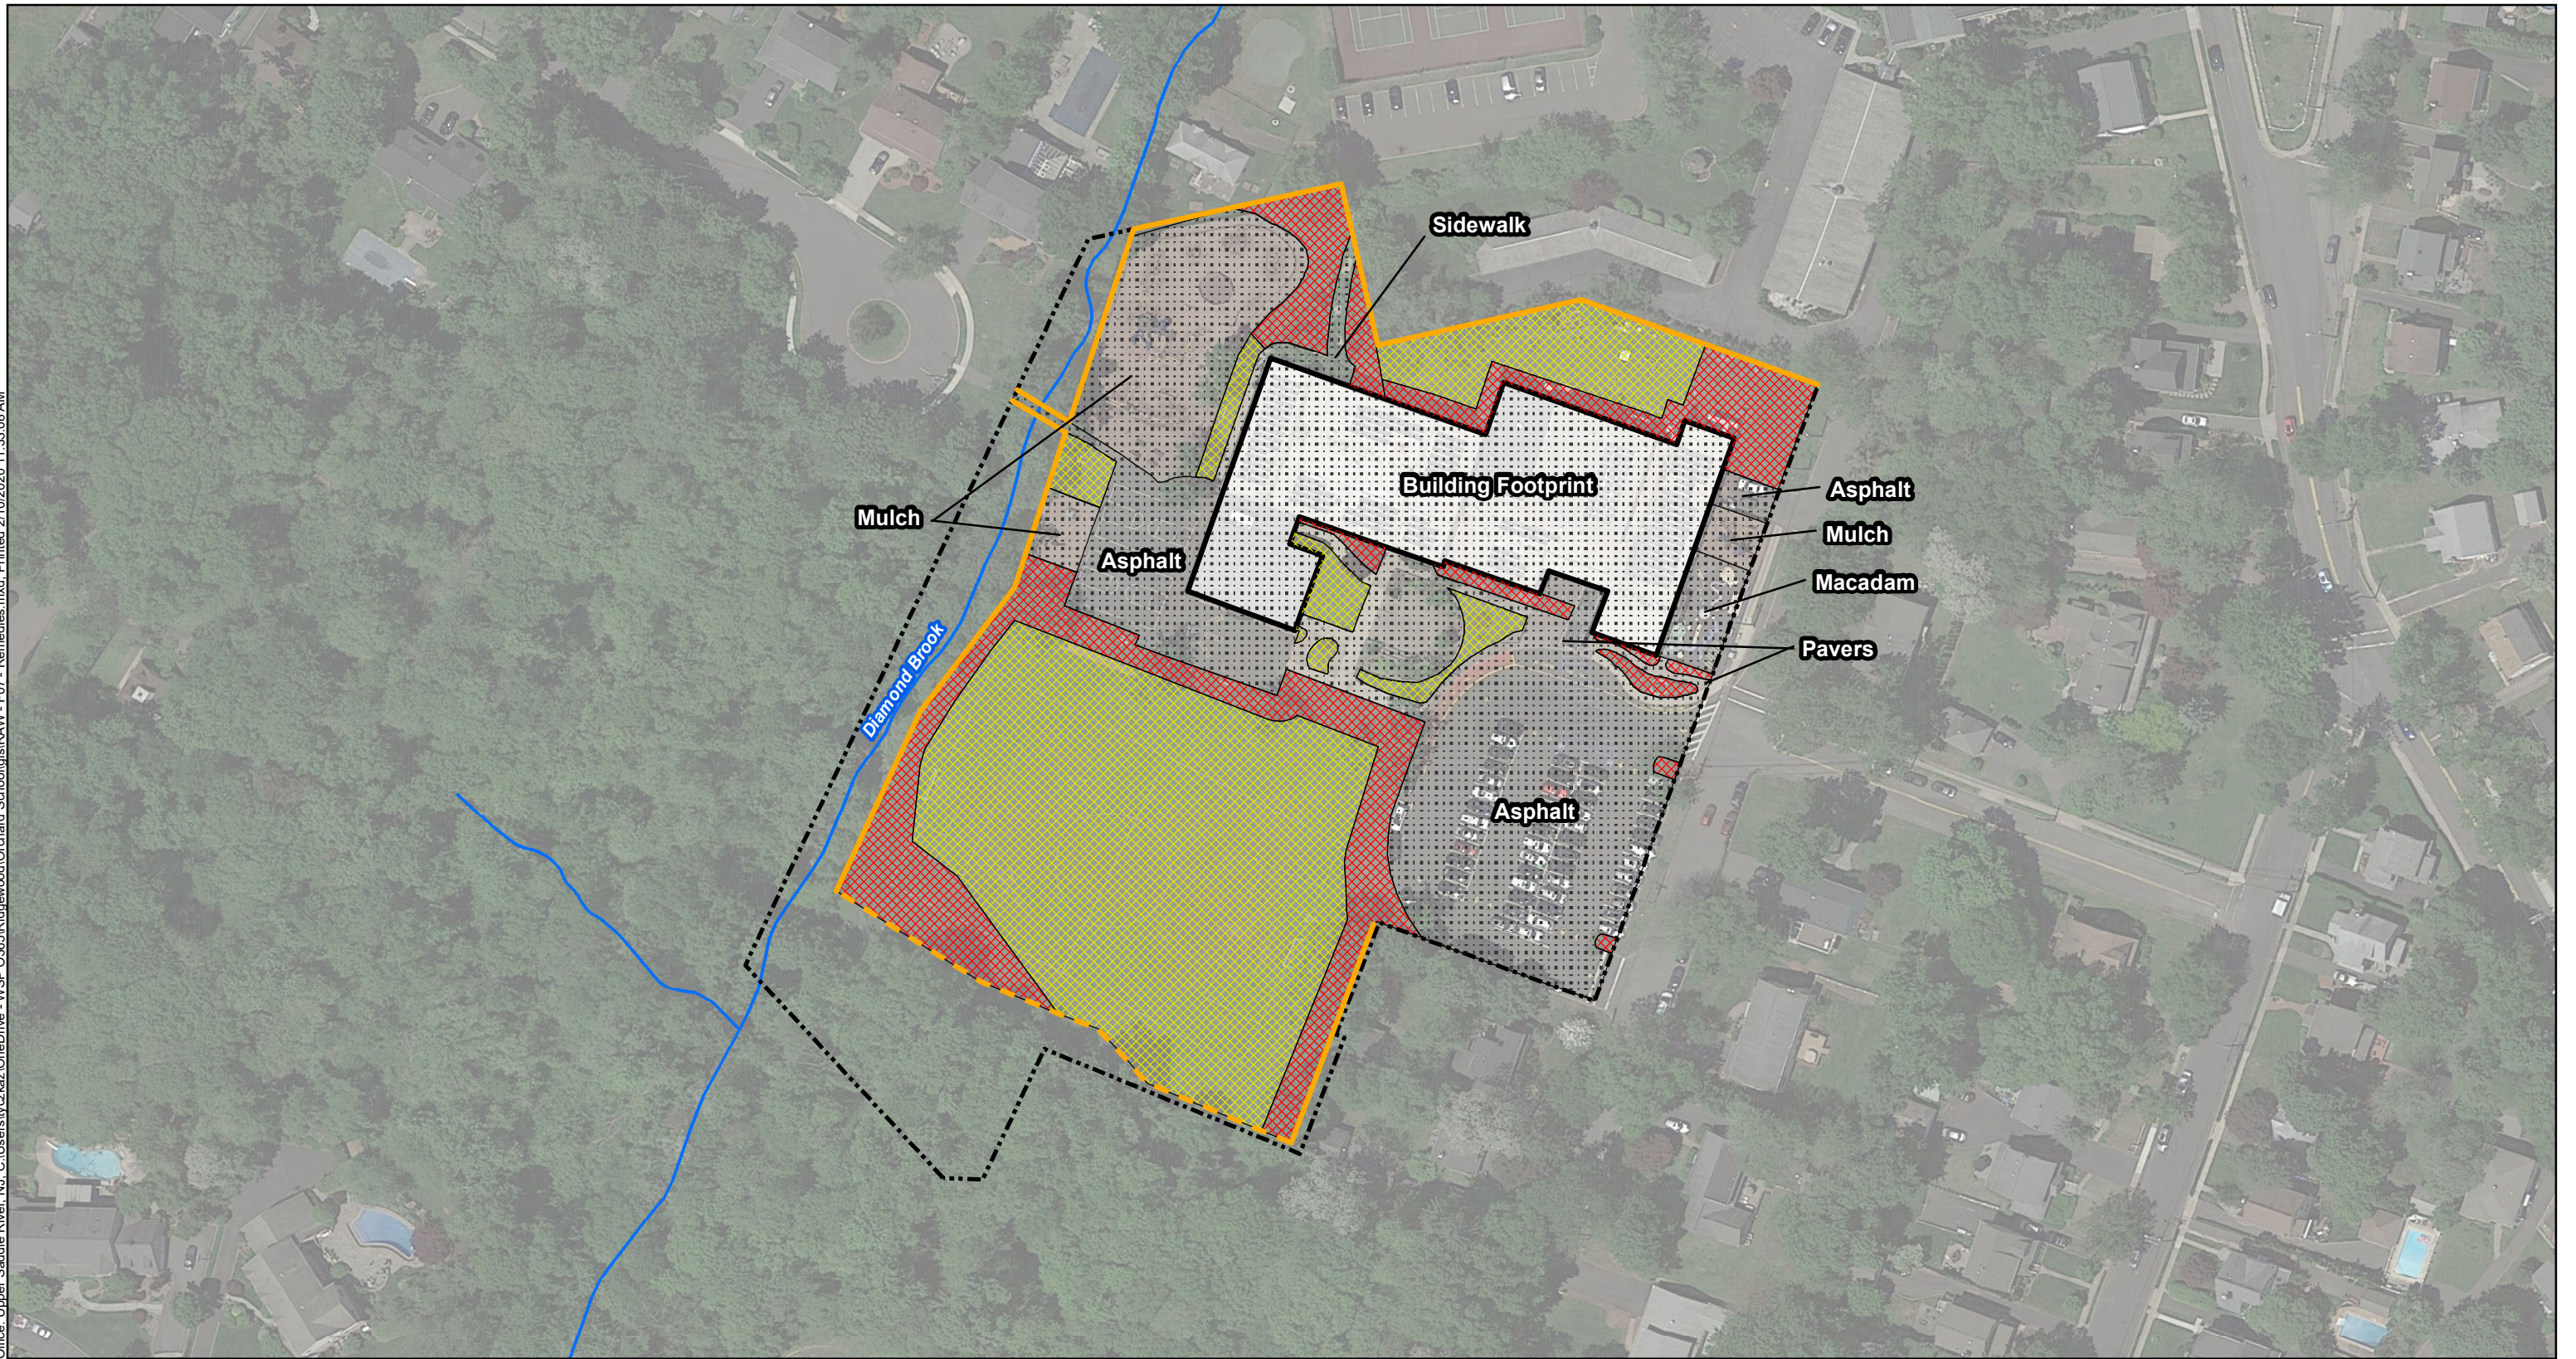
Office: Upper Saddle River, NJ, C:\Users\stz\kz\OneDrive - WSP\0365\Ridgewood\Orchard\_School\GIS\RAW - F07 - Remedies.mxd, Printed 2/10/2020 11:33:08 AM

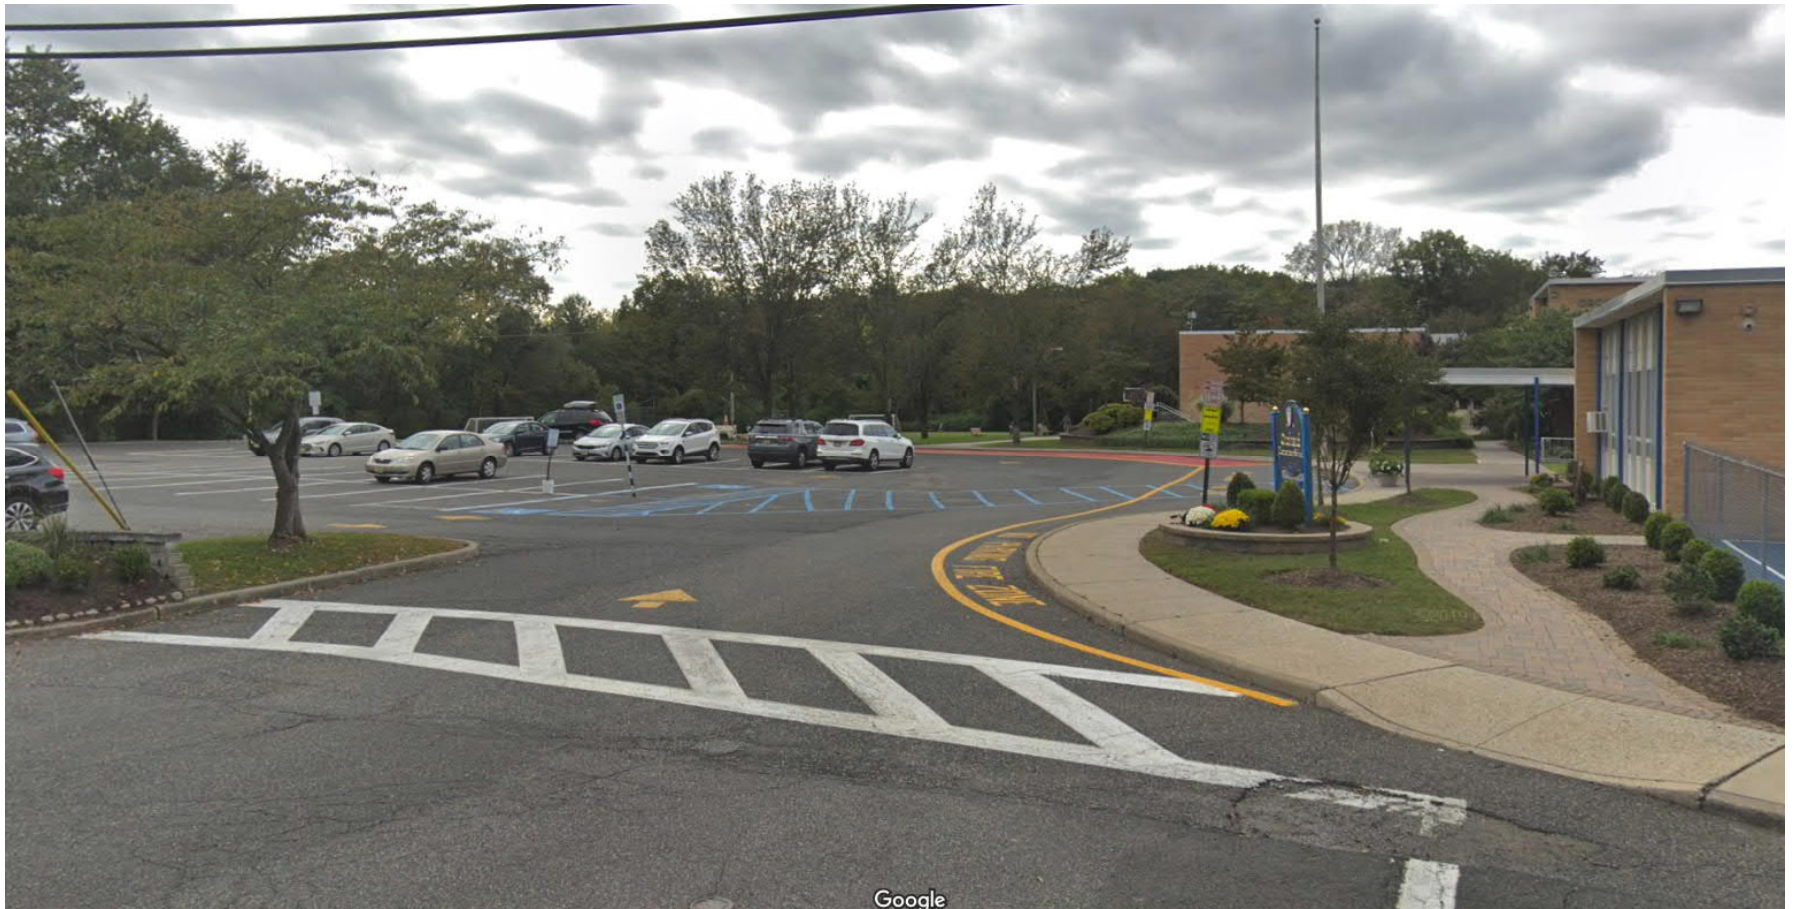
Photograph 1: View looking west showing the existing impervious surfaces (asphalt parking lot, cement and paver sidewalks, and the building).

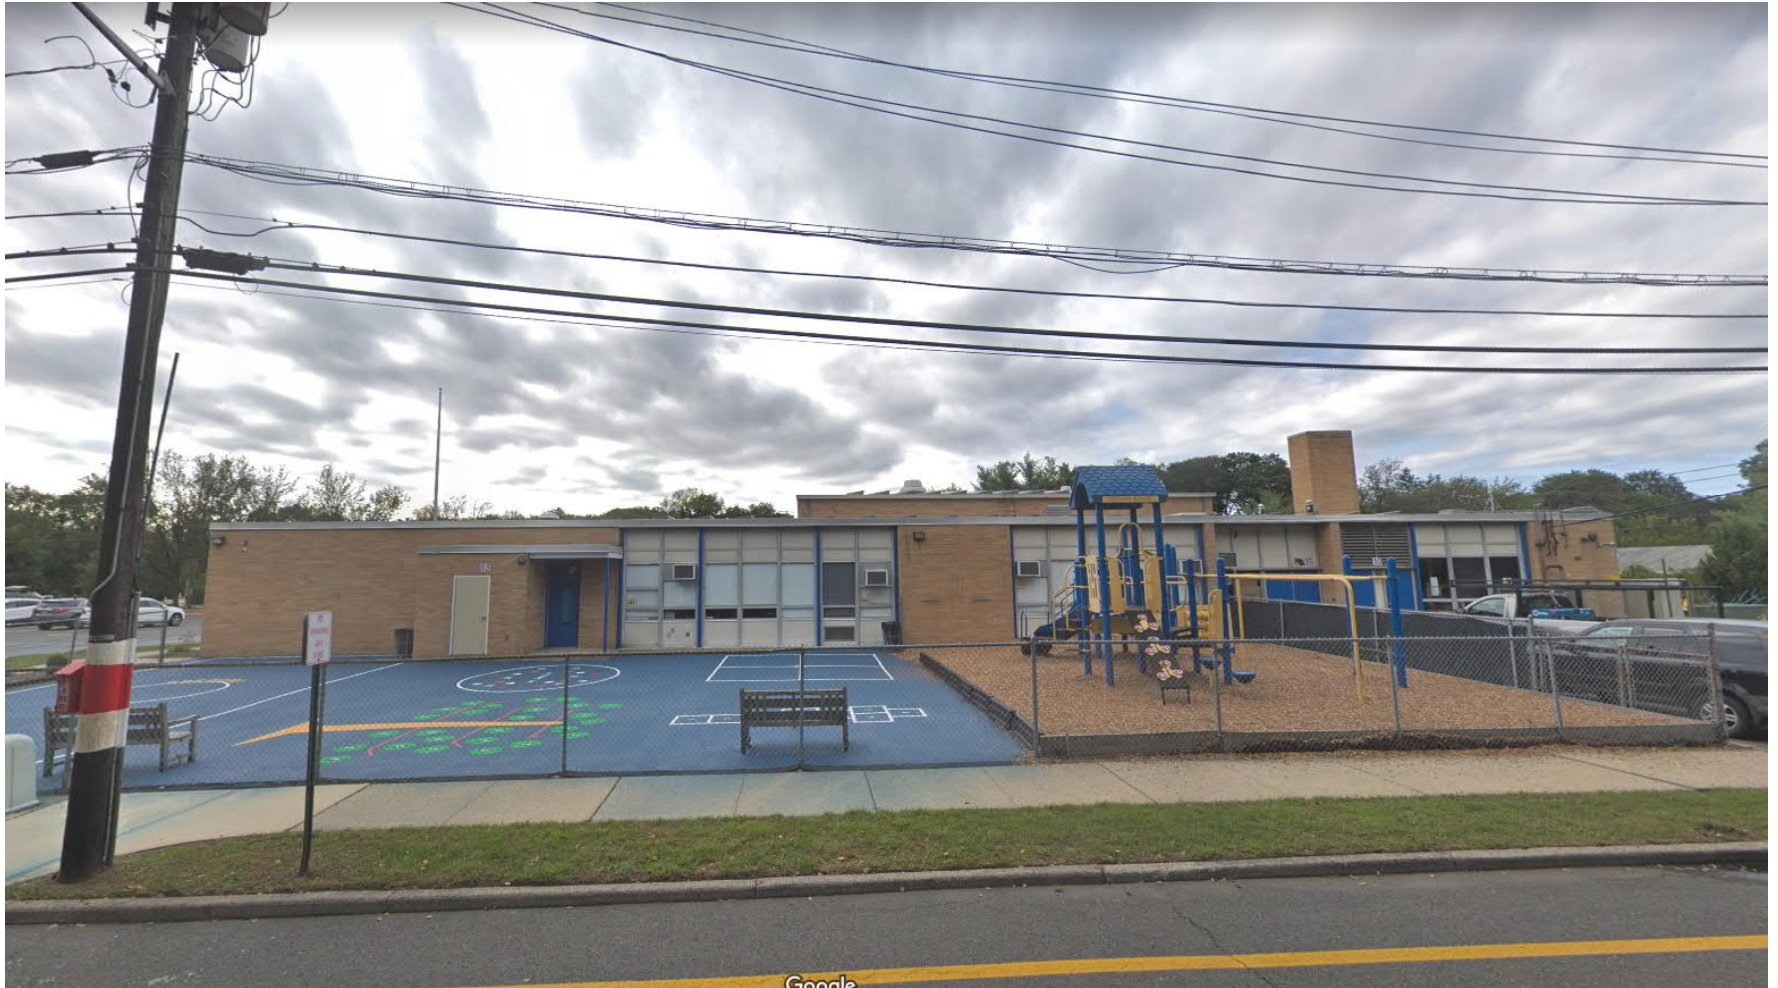
Photograph 2: View looking west showing the existing impervious surfaces at the eastern portion of the building (macadam play area, cement sidewalk, mulch area and the building).

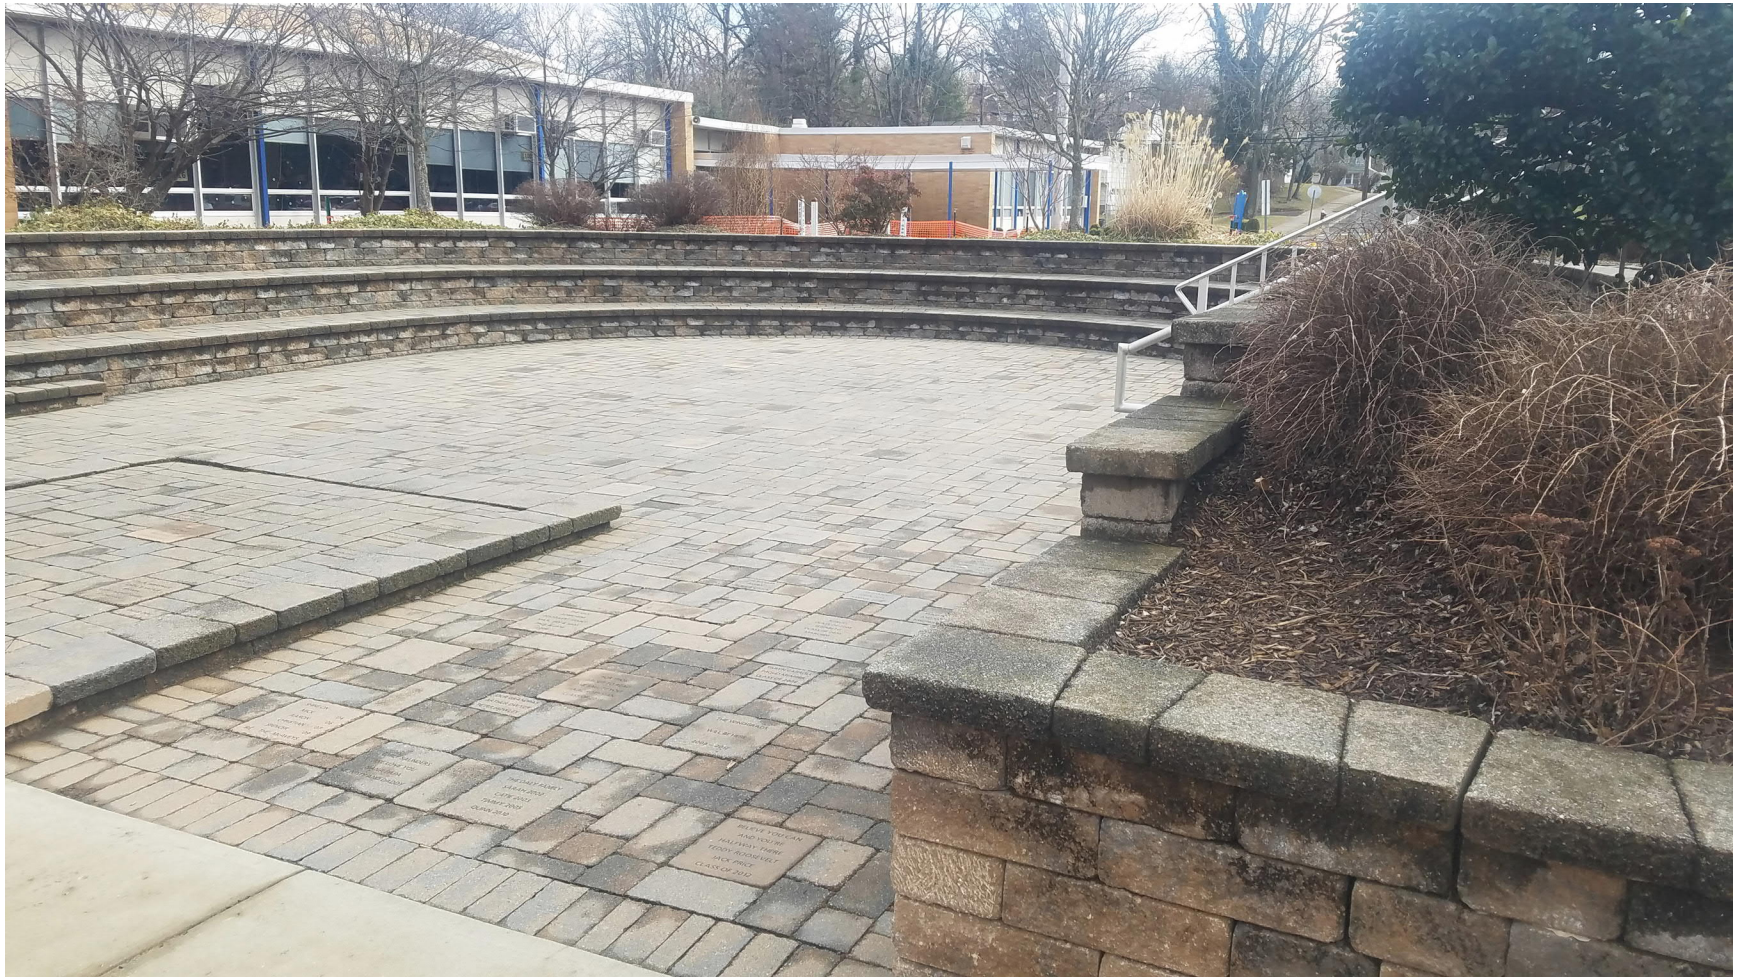
Photograph 3: View looking east showing the existing impervious surfaces (paver block) at the front of the building - amphitheater area.

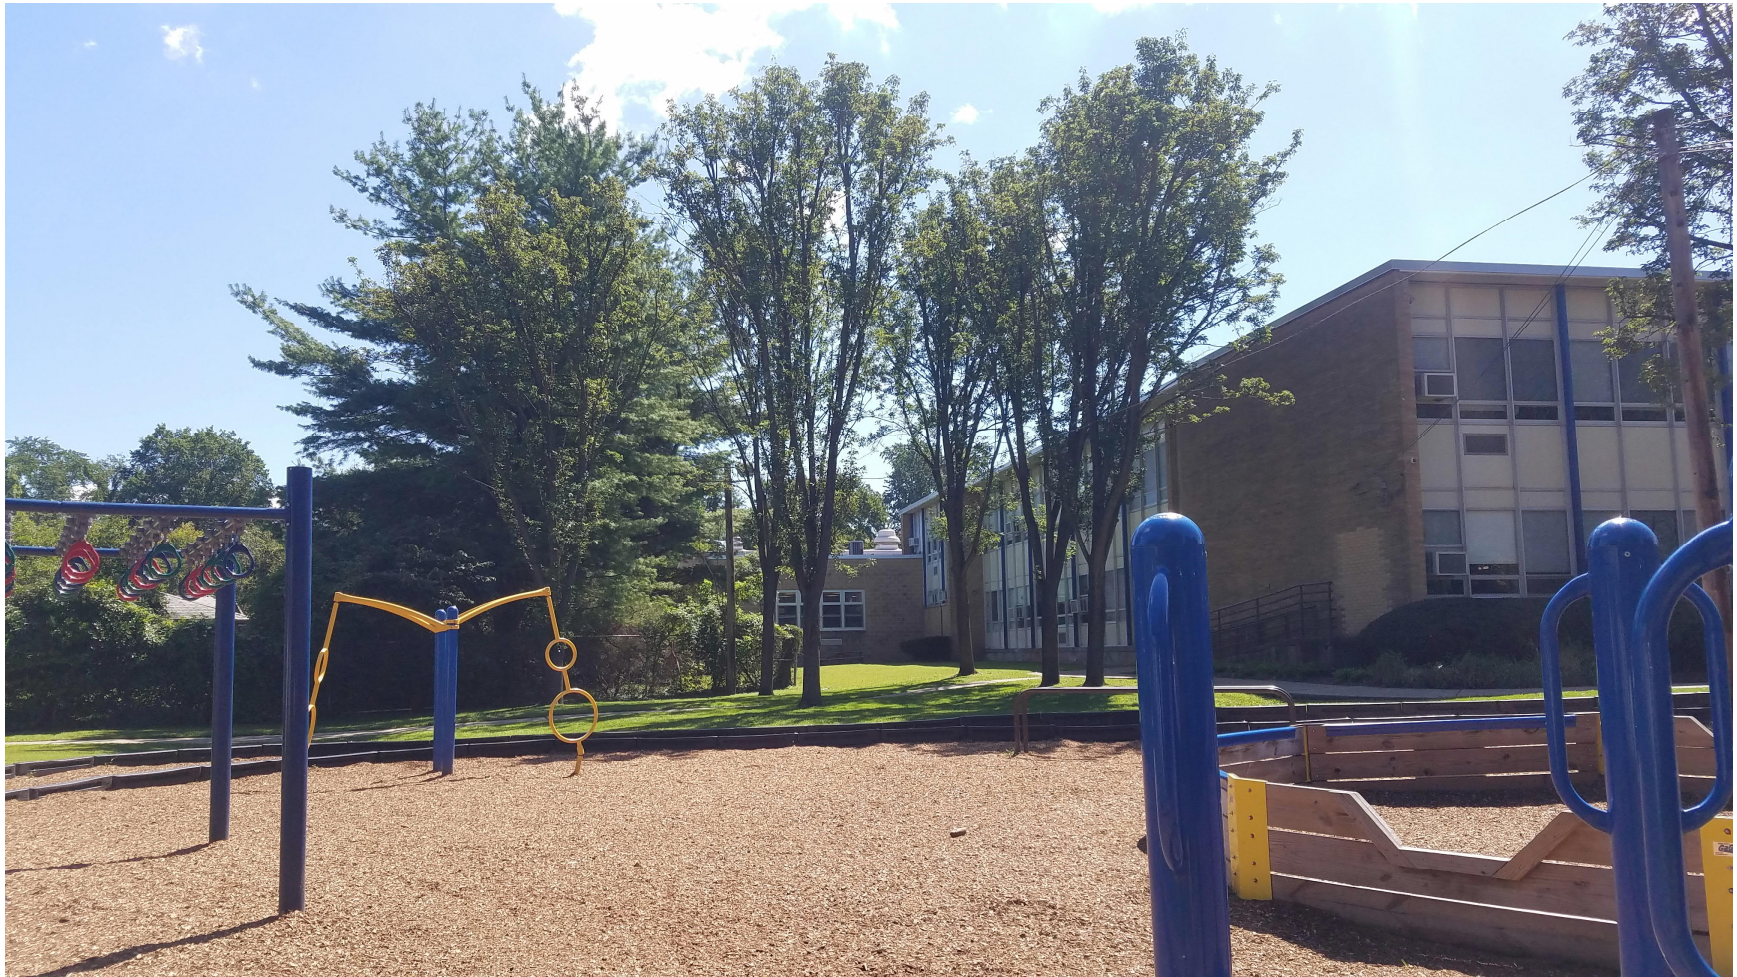
Photograph 4: View looking east showing the mulched playground area at the western portion of the building.

During the excavation of the playground area biodegraded woodchips were removed to a depth of approximately one foot below grade. The excavation revealed that little "ash" was present in the playground area and that the majority of the fill in this area of the property was scrap metal. Approximately 10 cubic yards of 'ash fill' was removed and large portions of scrap metal (anything from several inches to several feet in length) were manually separated and transported to a metal recycling facility for proper disposal (approximately 1,500 pounds). Additionally, a review of the grading plan indicated that a build-up of fill-material along the border of the existing playground would create a trip-hazard for the elementary students playing on the asphalt pavement. To eliminate this hazard, portions of the asphalt playground were extended to cover limited shallow occurrences of 'ash-fill' material.
